No. FHWA/RD-81/045

# CONSTITUENTS OF HIGHWAY RUNOFF

## Vol. IV. Characteristics of Runoff from Operating Highways. Research Report

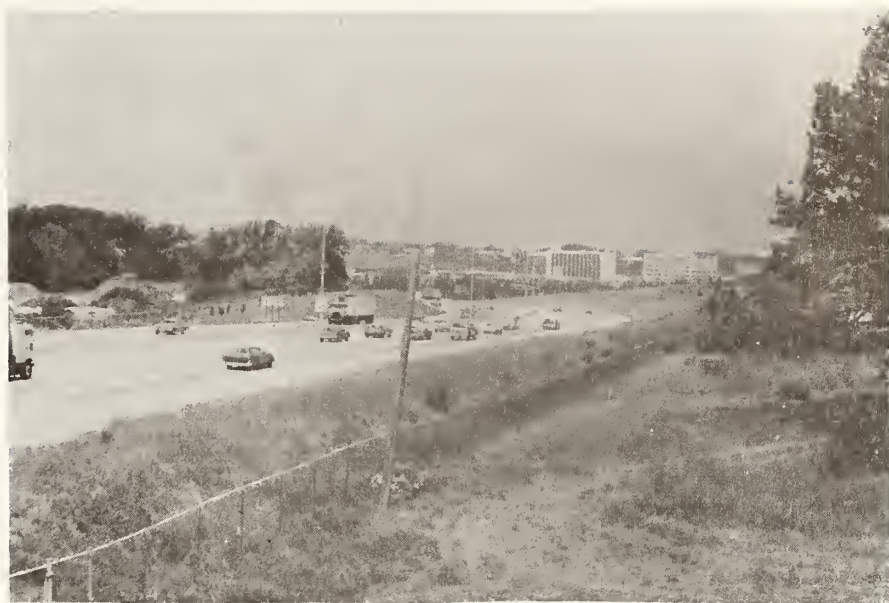
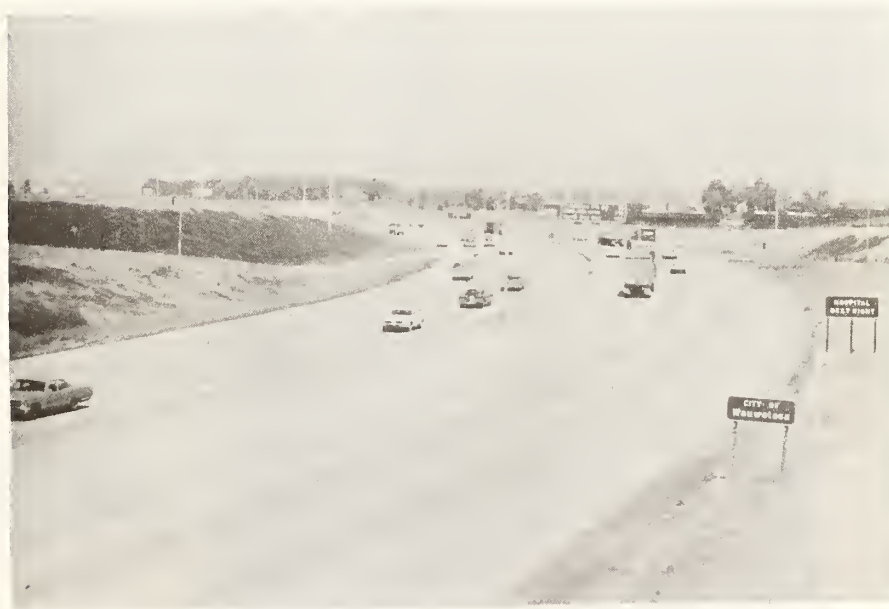
Figure 1. Typical photographic view, (looking north) Hwy. 45 site, Milwaukee, Wisconsin.

Among the three sites in Milwaukee, WI, the largest site was located on state Hwy. 45 and had a drainage area of 106 acres (42.9 ha). Two typical photographs of this highway are shown in Figure 1. The other two Milwaukee sites were significantly smaller in size (less than 3.0 acres area) but were selected for the investigation of runoff from an all paved (impervious) area site located on interstate I-794 (Figure 2) and an all pervious (unpaved) area site located on an inlet on Hwy. 45 (Figure 3).

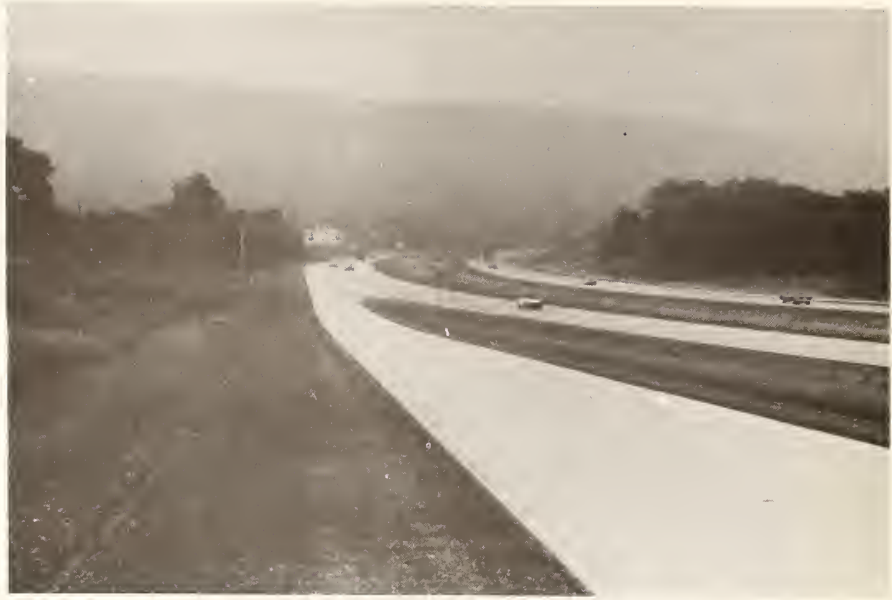
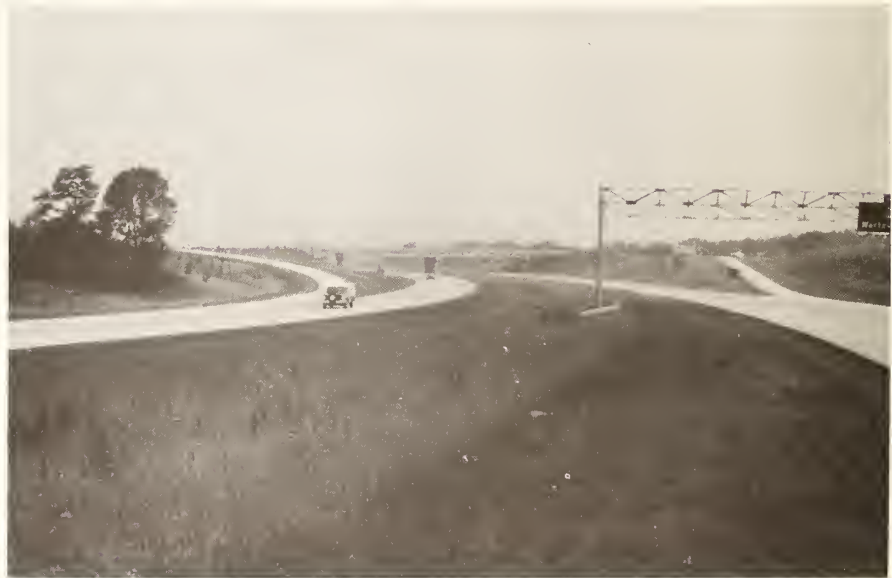
**Figure 4. Typical photographic views, I-81 site, Harrisburg, Pennsylvania.**

Harrisburg, PA was the only site located in a rural environment among the selected sites (Figure 4). All the other sites were located in urban/suburban environments (Figure 5 and 6). The locations of the monitoring points for all of these sites, either in the sewer, or at the outfall, were such that the runoff from the entire upstream drainage area could be monitored. A summary of the important characteristics of the selected sites is shown in Table 1. The average, daily traffic at these sites varied from a low of 24,000

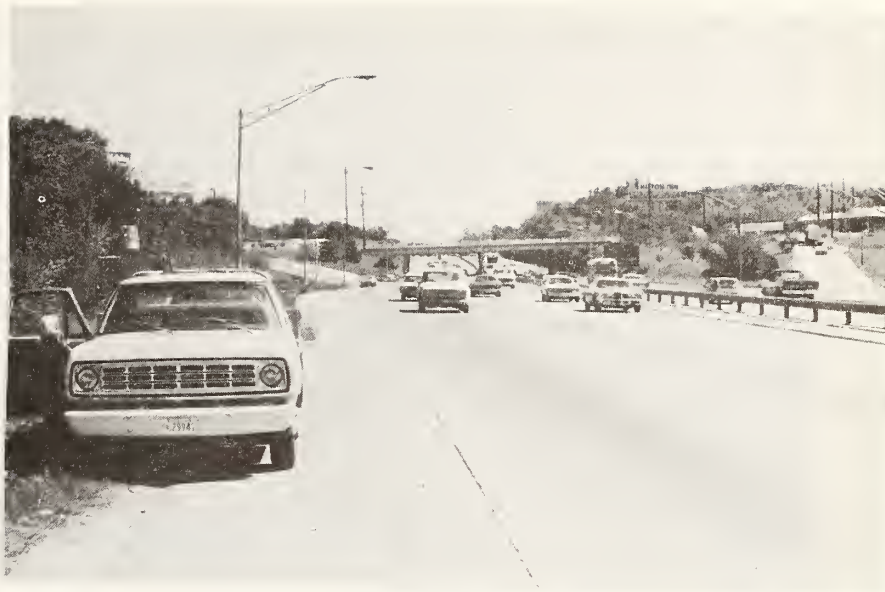
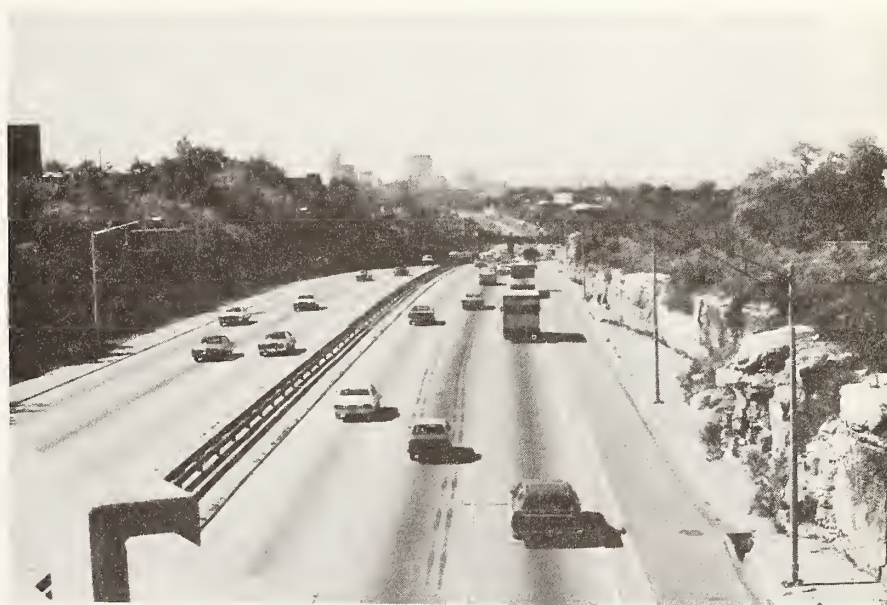
**Figure 5. Typical photographic views, I-40 site, Nashville, Tennessee.**

View looking east

View looking west

areas of cemeteries and private residences adjoining the highway right-of-way. Twenty and a half acres (8.3 ha) are paved (impervious) areas constituting 37% of the total drainage area. Included in the paved area is concrete pavement, asphalt shoulders, and approximately one acre (0.4 ha) of rock cut (see photo Figure 5).

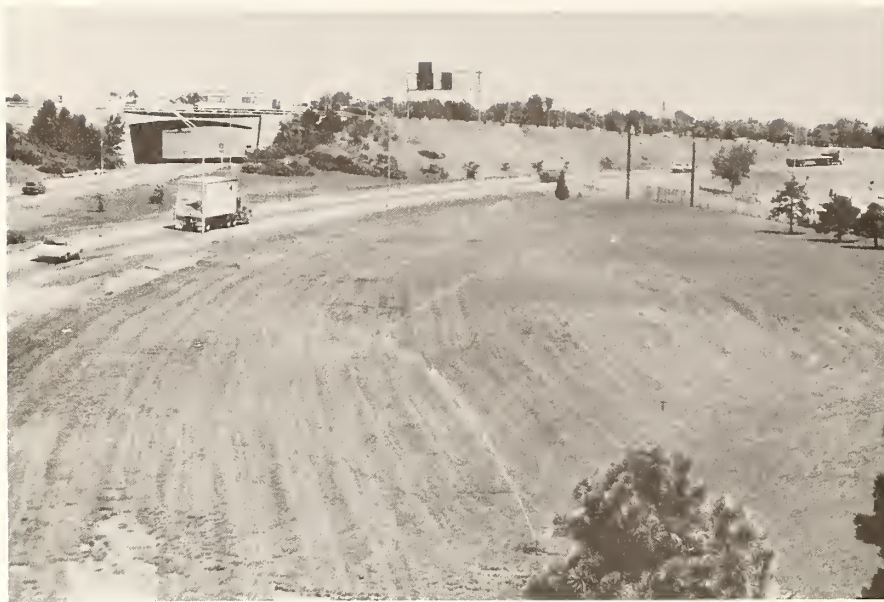
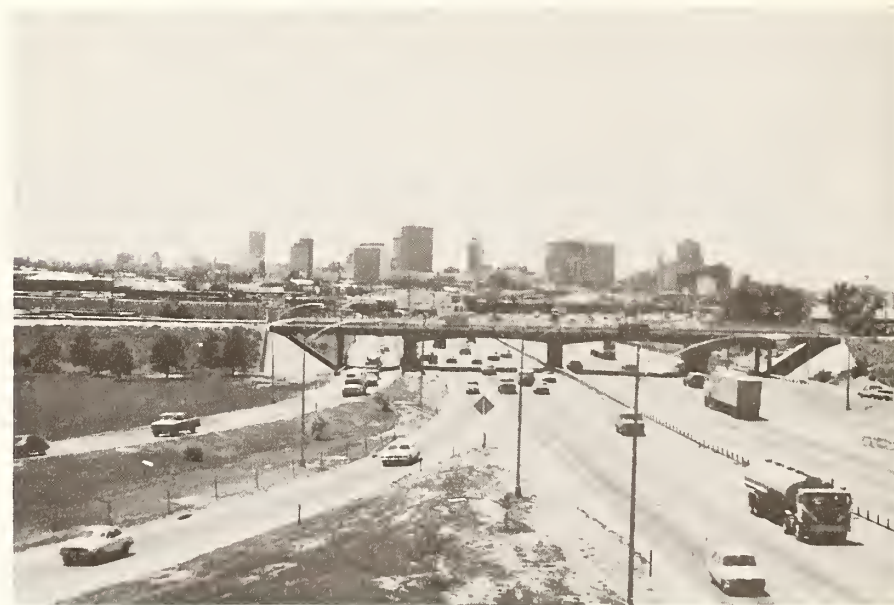
**Figure 6. Typical photographic views, I-25 site, Denver, Colorado.**

View looking north

View looking south

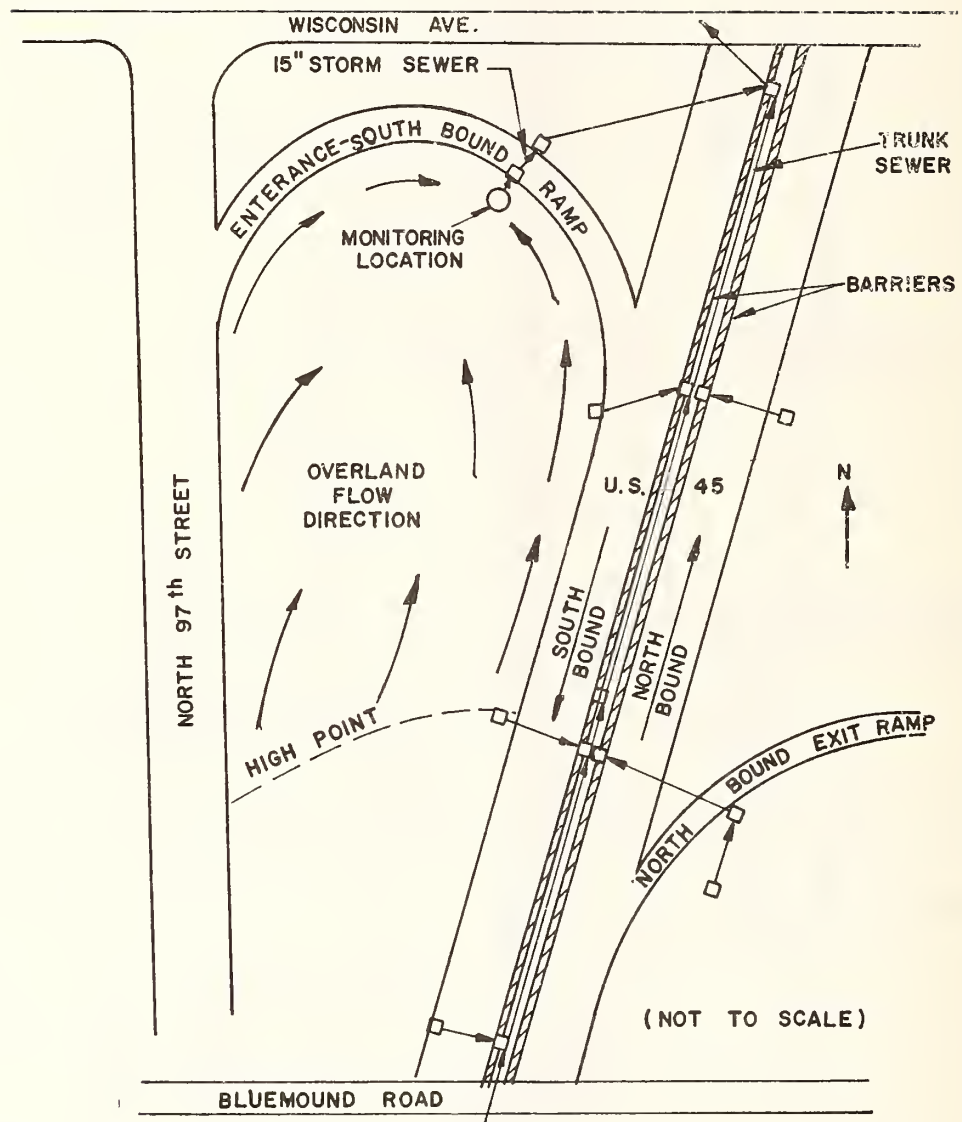
Figure 11. Schematic drainage plan, Hwy. 45 grassy site, Milwaukee, WI

Runoff monitoring was conducted at a shallow inlet near the Hwy. 45 on-ramp as shown in Figure 11. This site has a shallow cut slope of about 3.2% from the high point at 97th Street to the low point monitoring location near the ramp. Grades for the curved ramp ditches extending from both sides of the low point inlet vary from 1.4% to 3.3%. The grass area within the site area is not mowed except for an 8 ft (2.4 m) strip along Hwy. 45. The storm sewer at

the monitoring point is a 15 in. (38 cm) diameter concrete sewer.

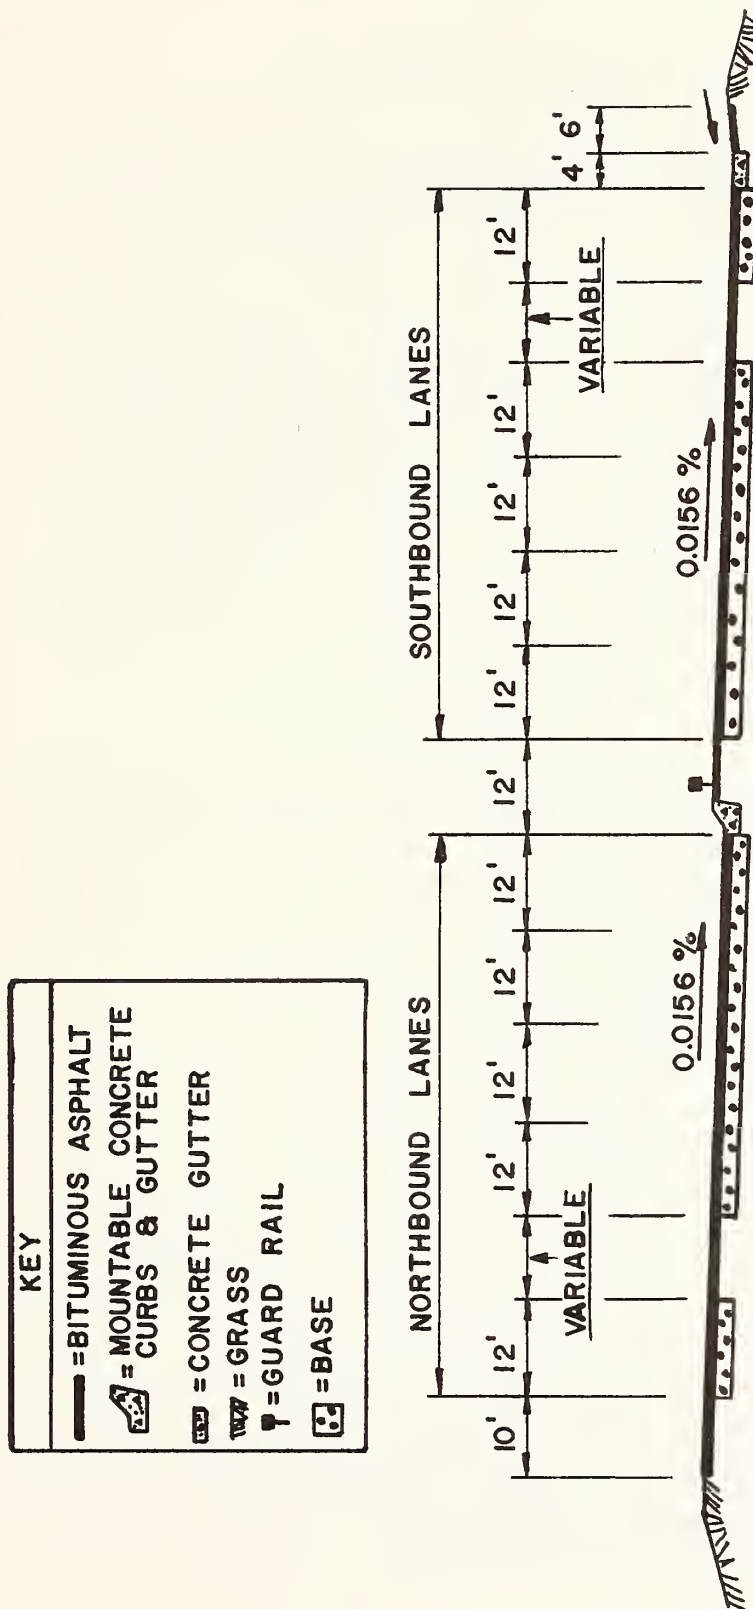
Figure 17. Typical cross section, I-25 site, Denver, CO (NOT TO SCALE)

ation and deceleration lane between the I-70 interchange ramps at Fox Street. At the I-70 interchange, the 2 outside lanes are dropped and the freeway becomes 8 lanes. Standard curb and gutters are placed in the outside freeway lanes and the left side of the ramp lane to provide separation between the freeway and the 2 ramps. Freeway grades vary from 0.10% to 0.40%. A typical section is shown in Figure 17.

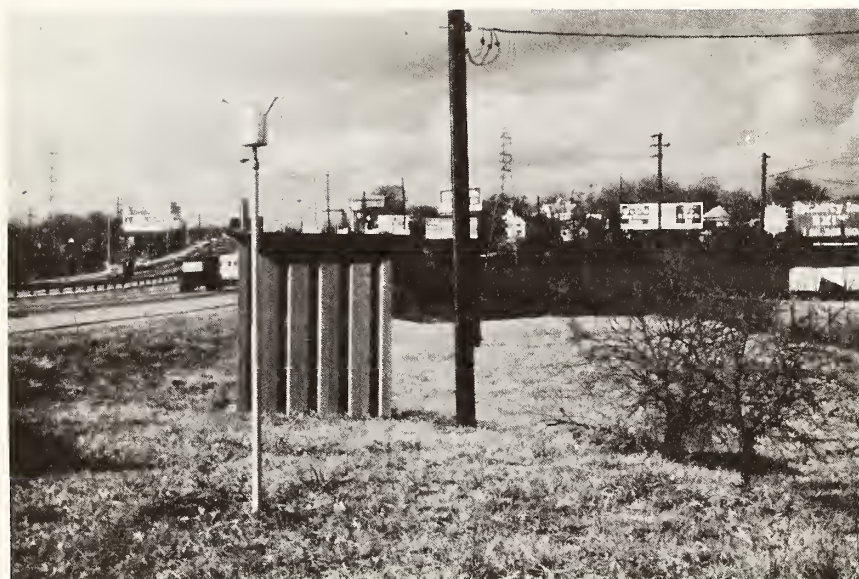
Figure 19. Typical dustfall bucket station,  
I-40, Nashville, Tennessee.

PA. The dustfall stations were erected in accordance with the recommended ASTM method (8-10 ft or 2.4-3.0 m above ground)(2). A typical dustfall station is shown in Figure 19. The collected dust contents were analyzed after each storm or once per month, whichever occurred first.

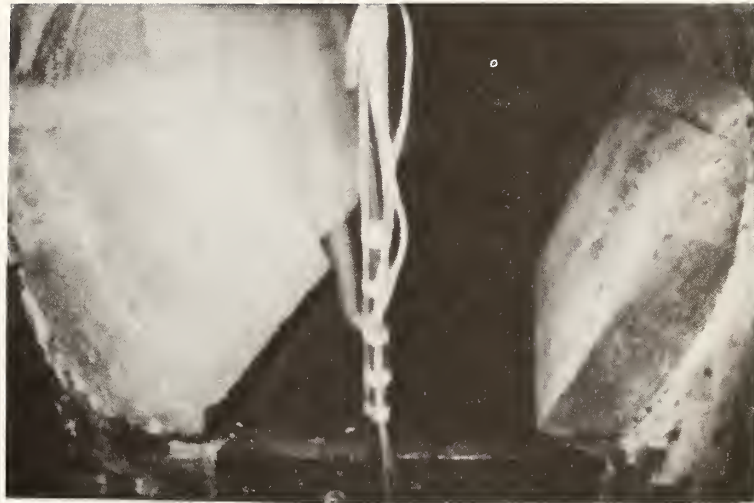
Figure 22. Palmer-Bowlus flume, Hwy. 45, Milwaukee, Wisconsin.

NOTE: Object in the middle of the picture is a plexiglass tube designed for obtaining a representative sample during a high flow.

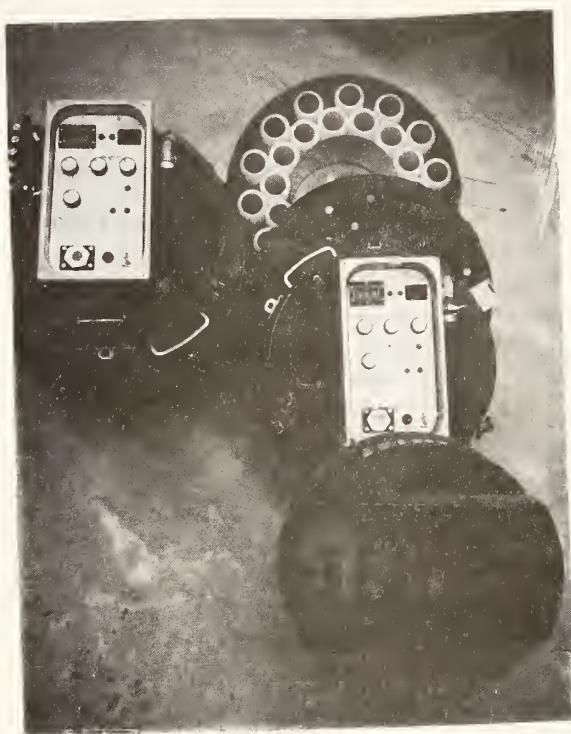
Figure 24. Typical ISCO Model No. 1680 water quality sampler used in this study.

Runoff sampling was conducted at all sites with Instrument Specialty Company (ISCO) water quality samplers (Models I392 and I680). A typical ISCO sampler is shown in Figure 24. The ISCO sampler is a self-contained portable unit capable of taking 28 discrete samples. The sampler can be operated using batteries or line electricity.

Sampling may be time or flow proportioned. Sample sizes between 40 ml to 450 ml may be selected for discrete samples. The two models, 1392 and 1680, used in the study represent the same basic sampler unit with the 1680 units being the updated version of the older 1392 model. The 1680 model provided several additional desirable sampling features. Most important of these features was that the 1680 model can be used for any time interval between 1 and 999 minutes. The minimum time interval on the 1392 model is 15 minutes on standard units, but could be bought with 10 minutes interval features with special order instructions. A peristaltic pump is utilized on the samplers for pumping the runoff samples from the flow stream to the sample bottles. After each sample, the pump reverses the flow direction to air purge the intake tube and minimize cross contamination between samples.
